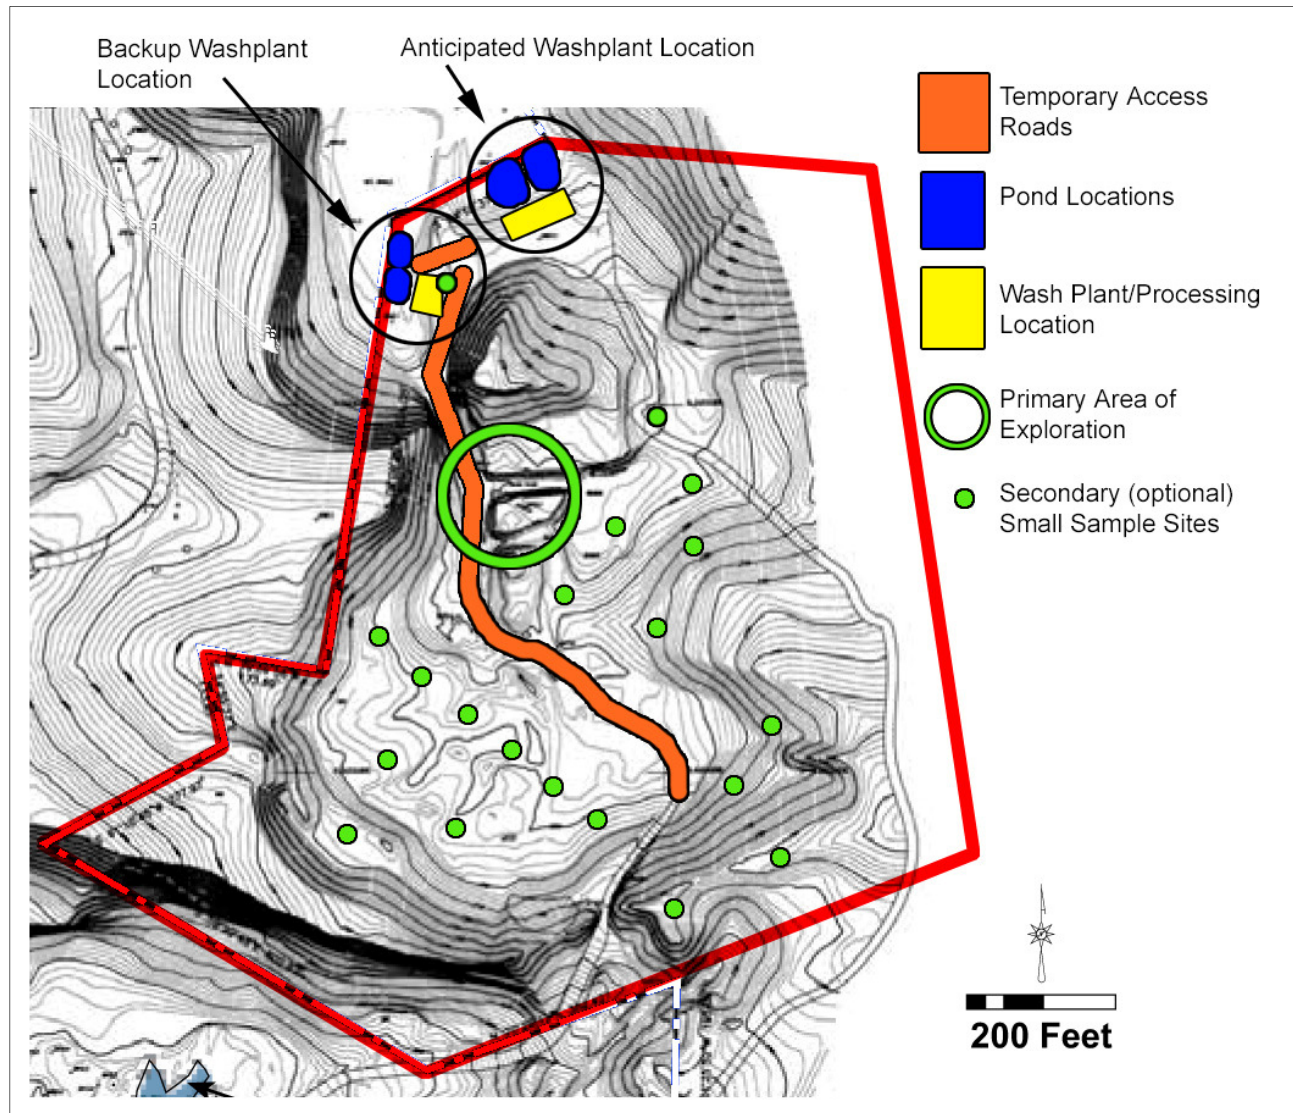
**Figure 4: Map of operations plan locations and key features.** Markings are not scale representations of the features, but rather indicate the areas which will contain the features. Access roads are existing though partially reclaimed. Anticipated washplant/pond location is indicated, but also a second “backup” site is indicated should the anticipated site be infeasible at the time of washplant installation. No BLM corner/survey markers, found at all but the most southerly corner of the claim, will be disturbed.
